LiteHouse Services Group LLC

Home Inspection Report

123 Any Street

Inspected on Thu, Apr 2 2020 at 4:05 PM

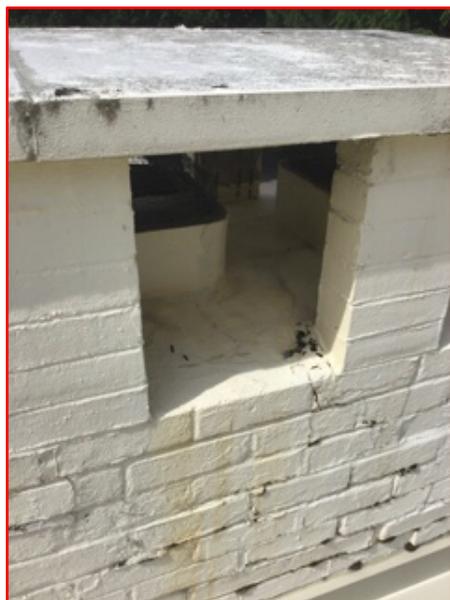
Figure 13-1

1) Comment 13: Minor cracking

Minor cracking visible in the chimney cap.

Some spalling observed on bricks.

Recommend correction to prevent continued deterioration.

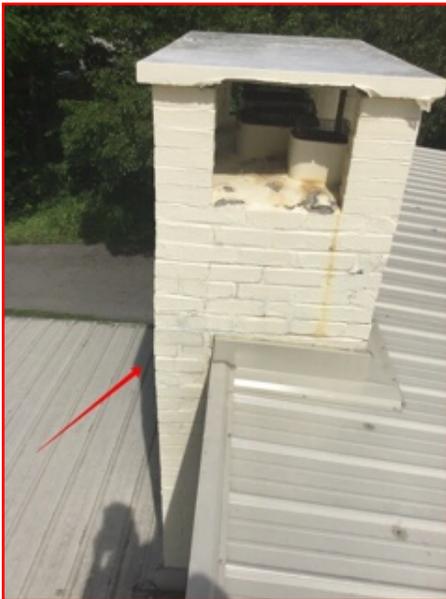
Figure 14-1

2) Comment 14: Inspector observed a slight bowing of the chimney stack. Recommend evaluation by a qualified contractor.

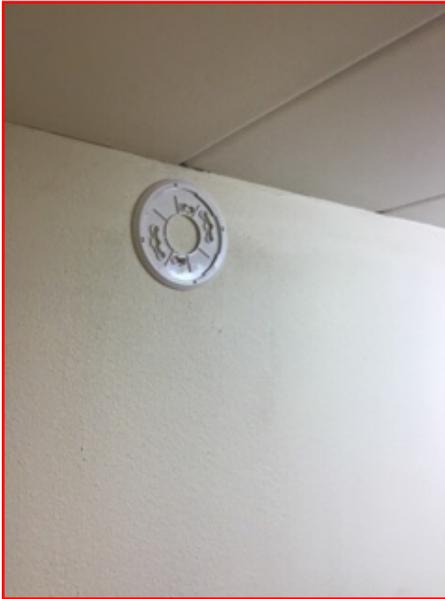
Figure 23-1

3) Comment 23: Some smoke detectors were missing at time of inspection. Others were missing batteries. Recommend installation of new smoke detectors in all appropriate areas.

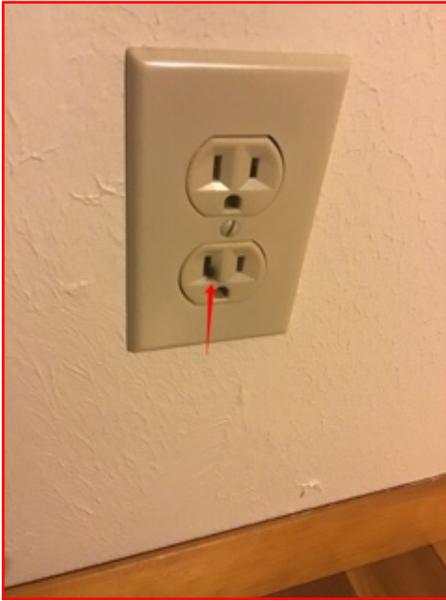
Figure 31-1

4) Comment 31: One outlet showed signs of previous arcing. Recommend further evaluation by a qualified electrician.

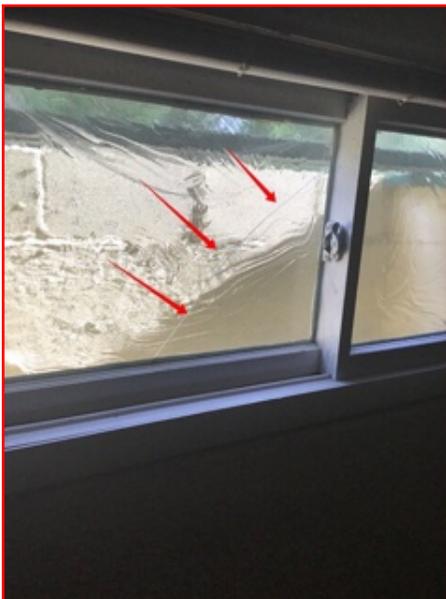
Figure 36-1

5) Comment 36: Glass pane was broken in window. Recommend replacement or repair by a qualified contractor.

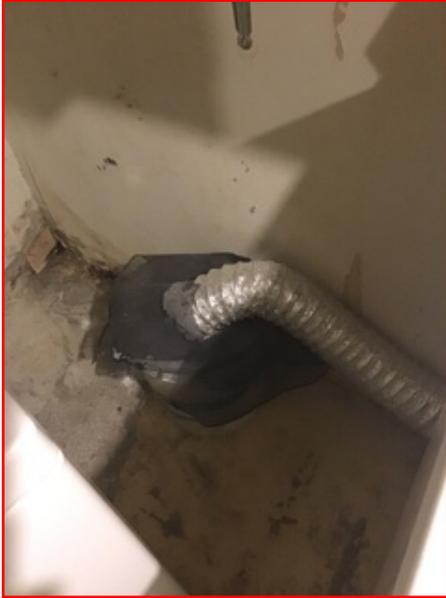
Figure 42-1

6) Comment 42: Dryer is vented to a bucket in the room. This can create moisture issues in the room and should be corrected.

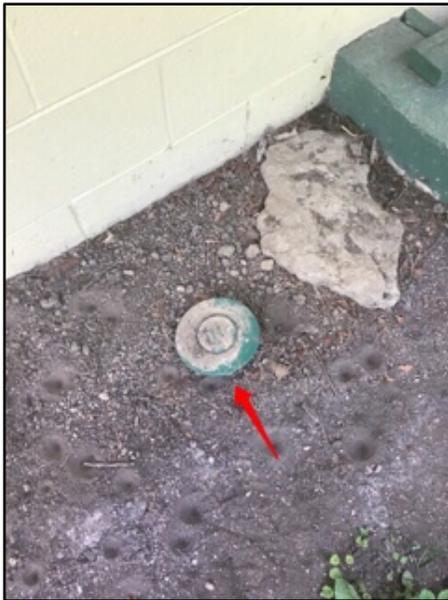
Figure 3-1

Comment 3:
Signs of previous termite control measures. Ask owner for more information.

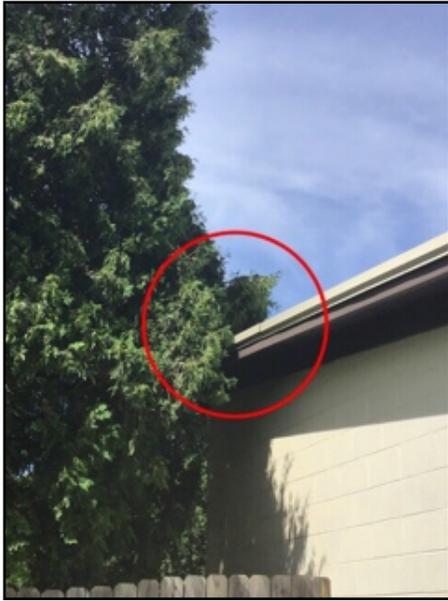
Figure 4-1

Comment 4:
The roof covering is in contact with tree limbs. Recommend trimming trees back from contact.

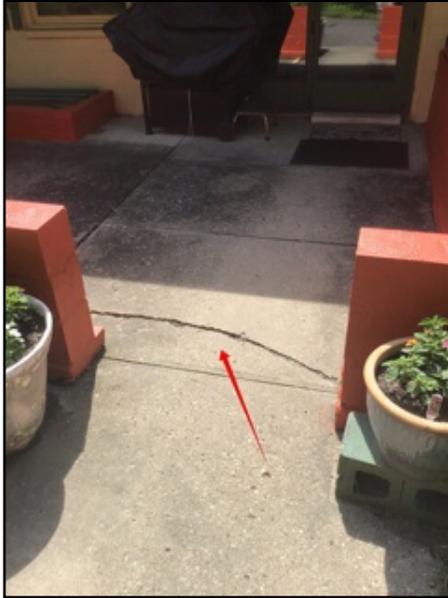
Figure 5-1

Comment 5:
Concrete showing cracks which are likely a sign of ground settlement.

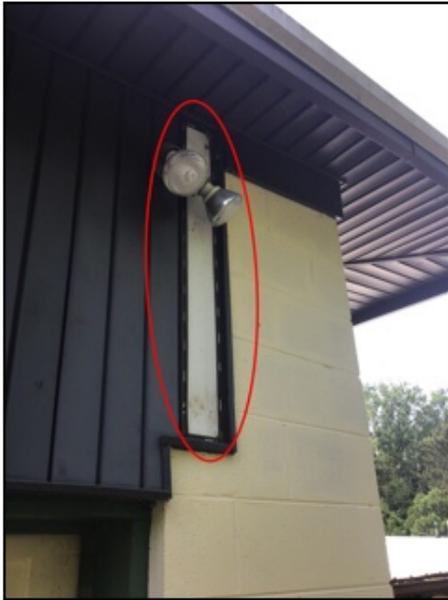
Figure 6-1

Comment 6:
Missing pieces of exterior trim in a couple places.

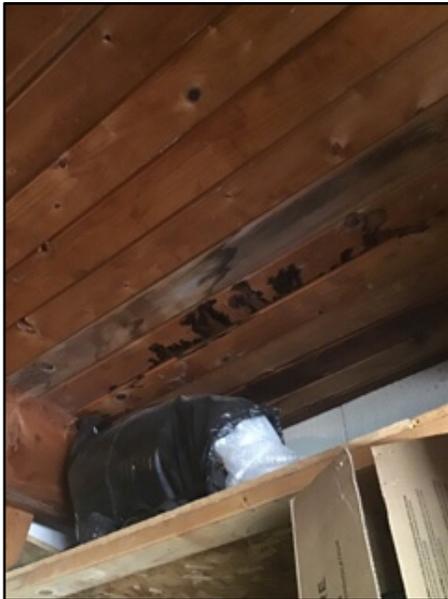
Figure 7-1

Some indication of prior roof leaks in the garage. Did not appear to be active at time of inspection.

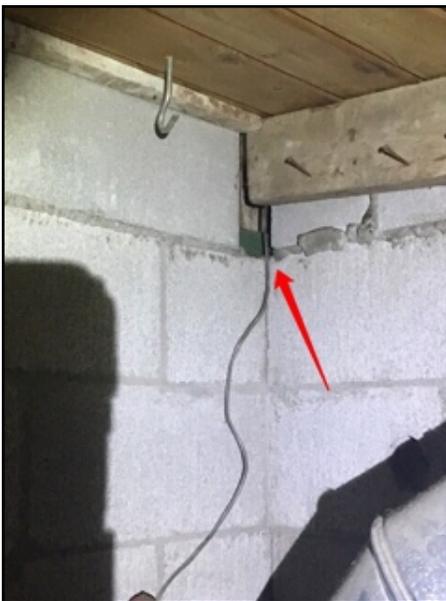
Figure 10-1

Comment 10:
Gap in corner of garage should be sealed to prevent pest infiltration.

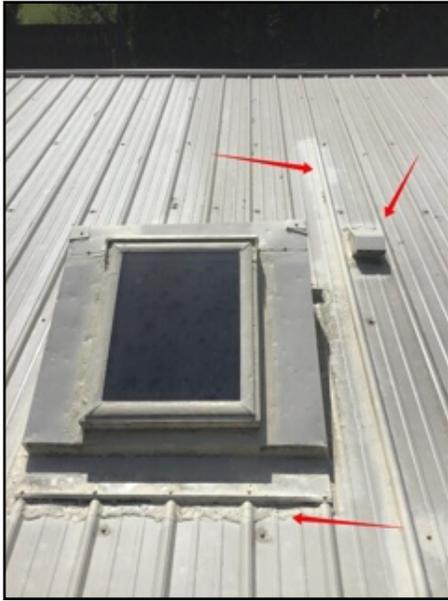
Figure 11-1

Owner disclosed that there have been some leaks in the roof in various locations but that they have been promptly repaired.

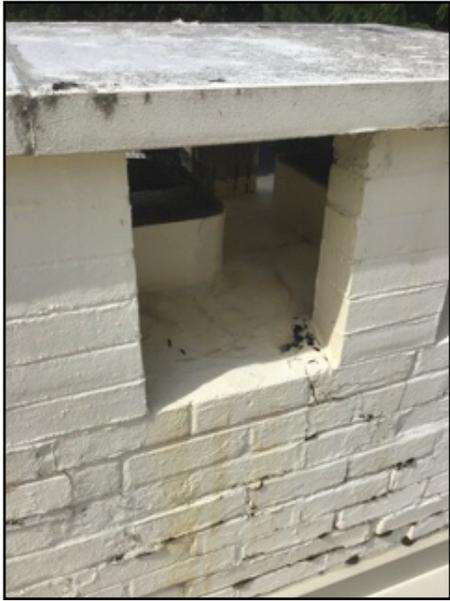
Figure 13-1

Minor cracking

Minor cracking visible in the chimney cap.

Some spalling observed on bricks.

Recommend correction to prevent continued deterioration.

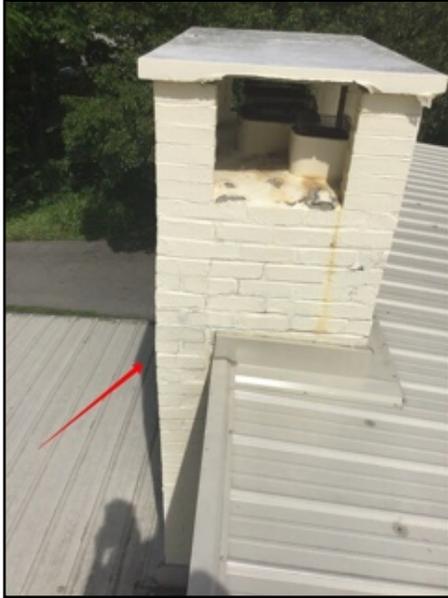
Figure 14-1

Inspector observed a slight bowing of the chimney stack. Recommend evaluation by a qualified contractor.

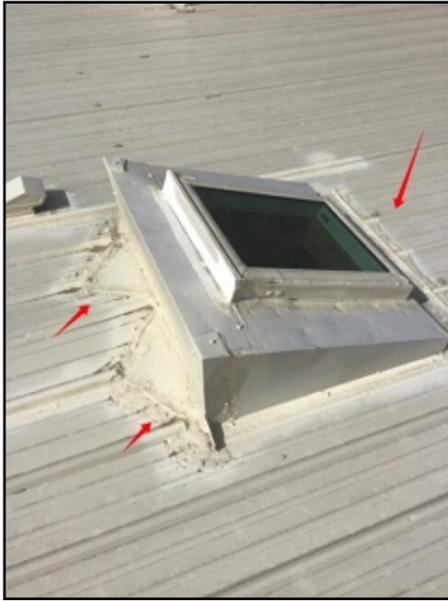
Figure 15-1

Owner disclosed prior leaking around one of the sky lights. This is common with sky lights.

Repairs were visible.

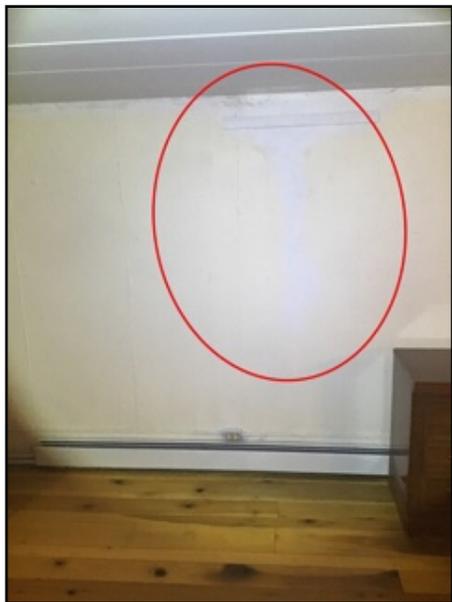
Figure 18-1

Signs of minimal prior water intrusion. Repairs visible. One area looks to have been caused by a leaking water pipe. It was dry at time of inspection.

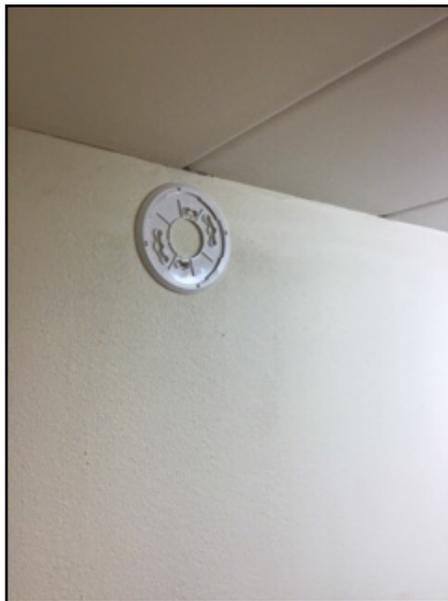
Figure 23-1

Some smoke detectors were missing at time of inspection. Others were missing batteries. Recommend installation of new smoke detectors in all appropriate areas.

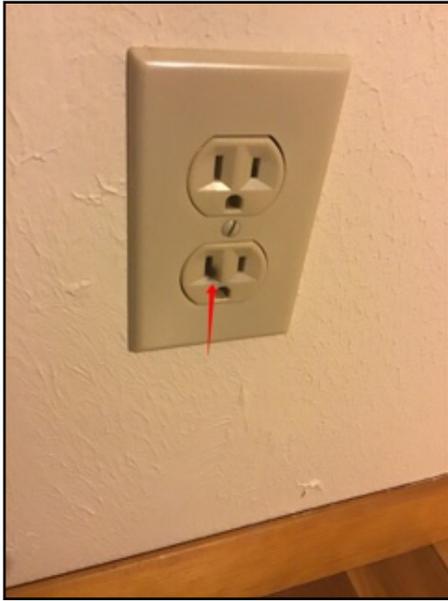
Figure 31-1

One outlet showed signs of previous arcing. Recommend further evaluation by a qualified electrician.

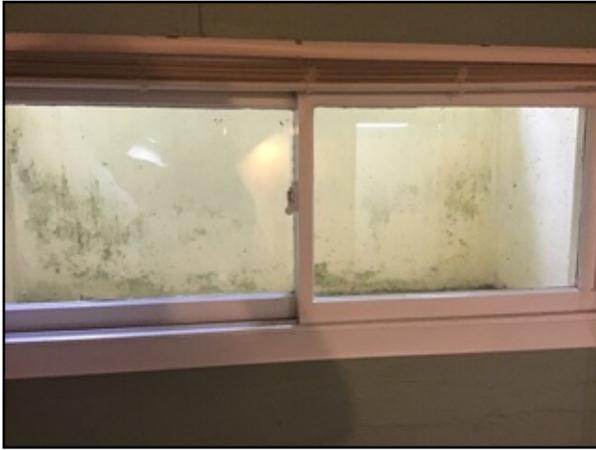
Figure 32-1

Comment 32:
Inspector could not open window. No screen.

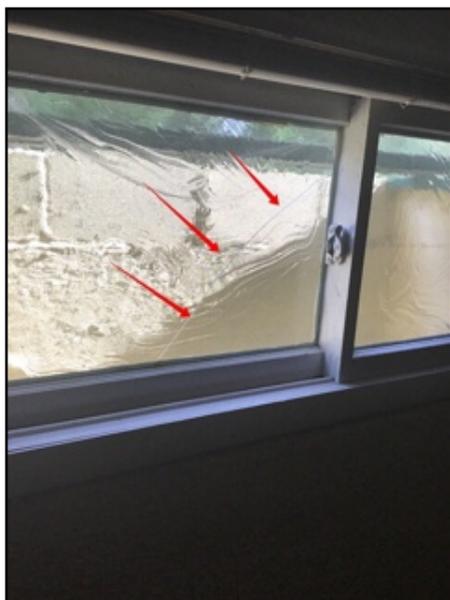
Figure 36-1

Glass pane was broken in window. Recommend replacement or repair by a qualified contractor.

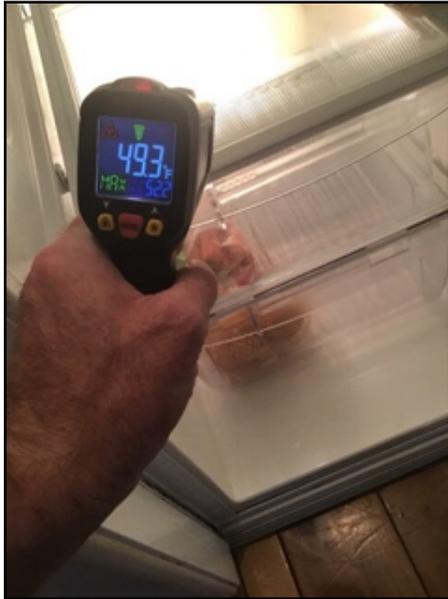
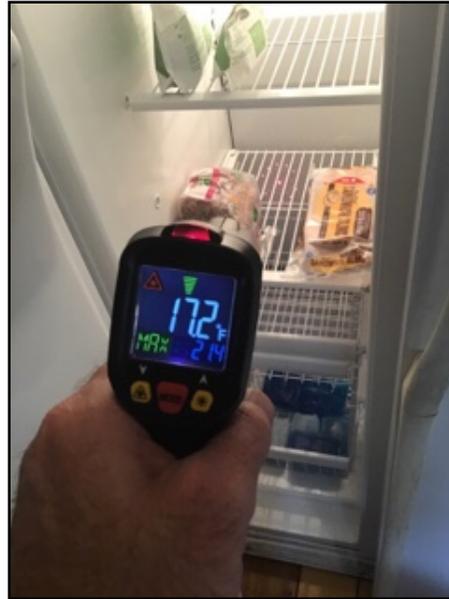
Refrigerator was running warm. Owner disclosed that the ice maker has never worked.

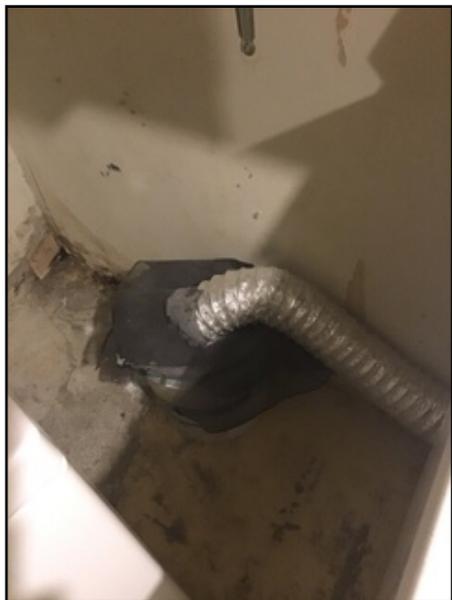
Figure 42-1

Dryer is vented to a bucket in the room. This can create moisture issues in the room and should be corrected.
