LiteHouse Services Group LLC

Home Inspection Report

123 Any Street

Inspected on Thu, Apr 2 2020 at 4:05 PM

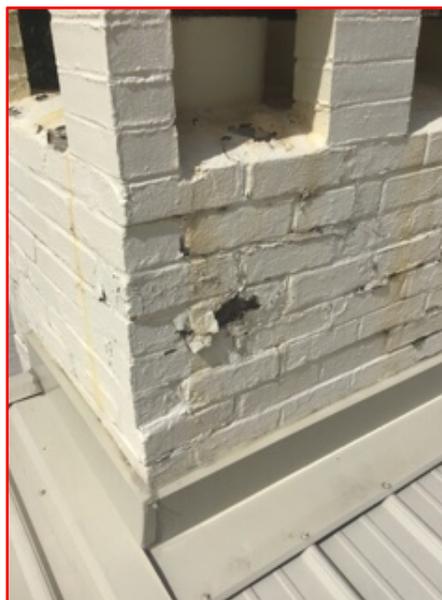
Figure 13-2

Minor cracking visible in the chimney cap.

Some spalling observed on bricks.

Recommend correction to prevent continued deterioration.

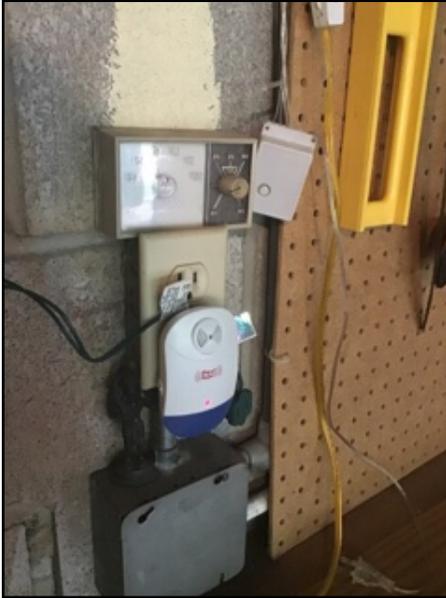
Figure 9-1

Comment 9:
Signs of active pest control in garage area.

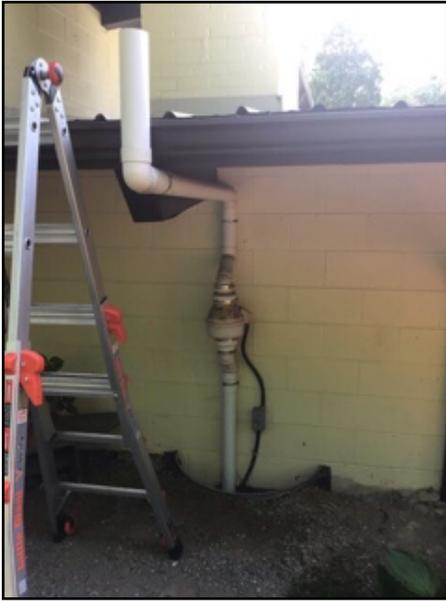
Figure 19-1

There is a radon remediation system installed. System was operating properly at time of inspection.

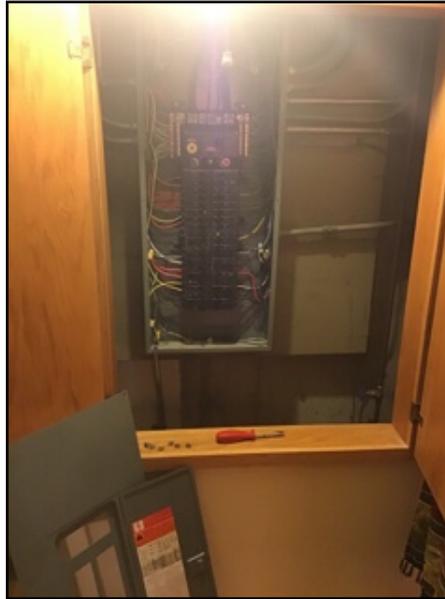
Service panel was in excellent condition and showed professional installation and wiring. There were no double tapped busses or breakers and panel was properly labeled.

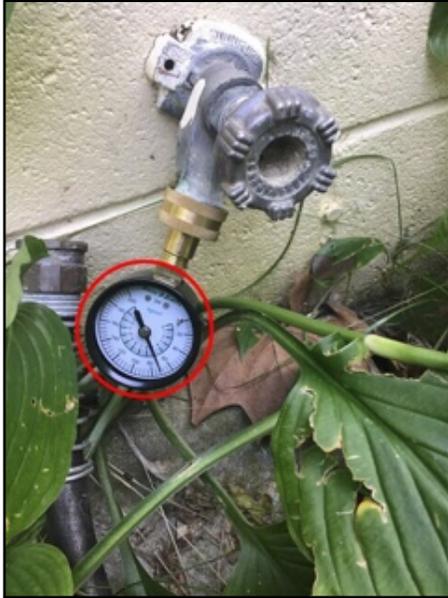
Figure 27-1

Comment 27:
Water pressure is good at 70 psi.

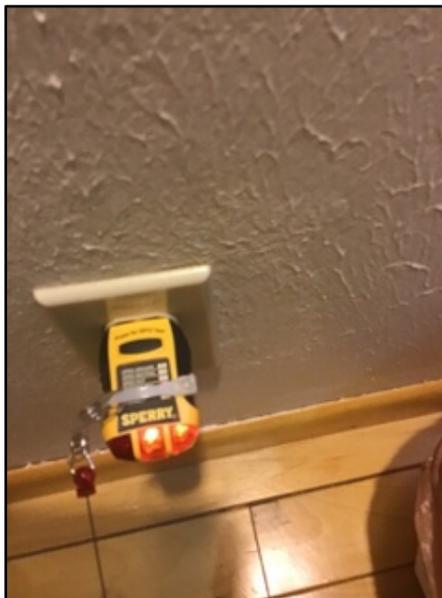
Comment 31:

One outlet showed signs of previous arcing. Recommend further evaluation by a qualified electrician.

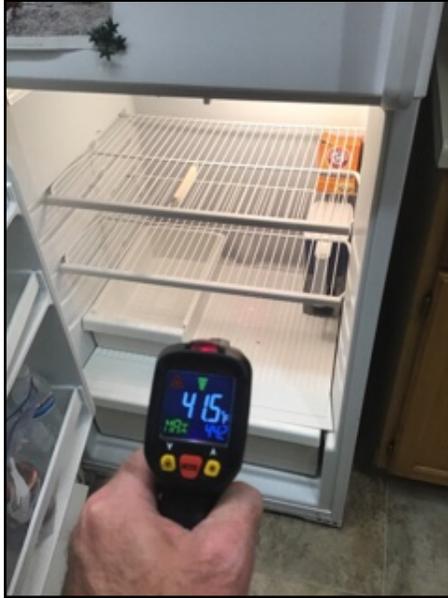
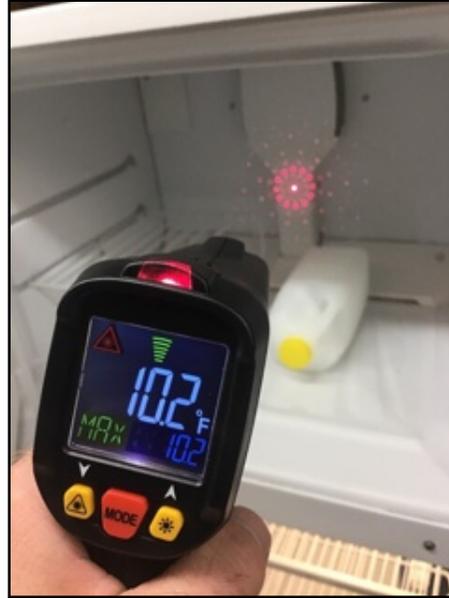
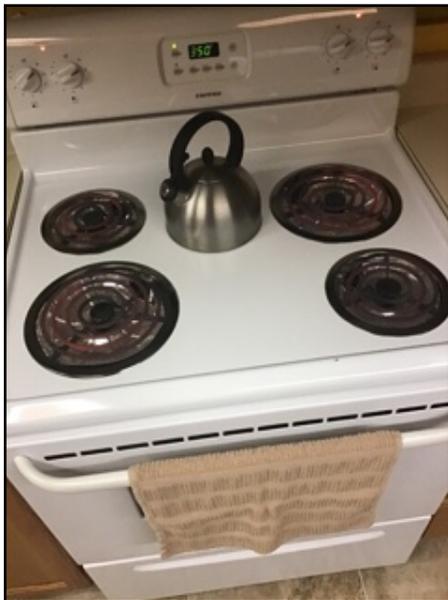
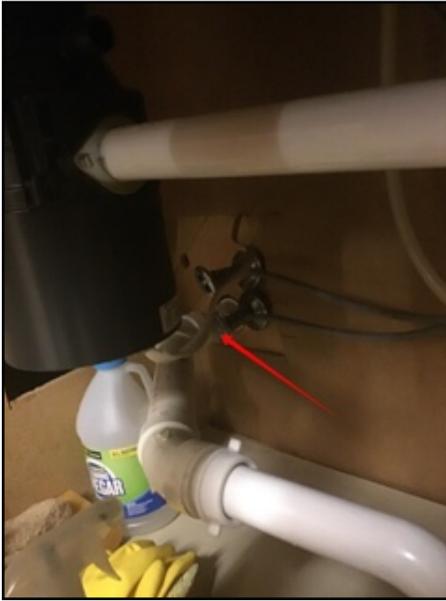
Figure 39-1

Basement kitchen in good working order. All appliances operated properly. Wiring for garbage disposal should be encased in conduit.
